Colonial Williamsburg Archaeological Reports

Archaeological Excavations on the Tazewell Hall Property

May 15, 1986
Re-issued July 2001

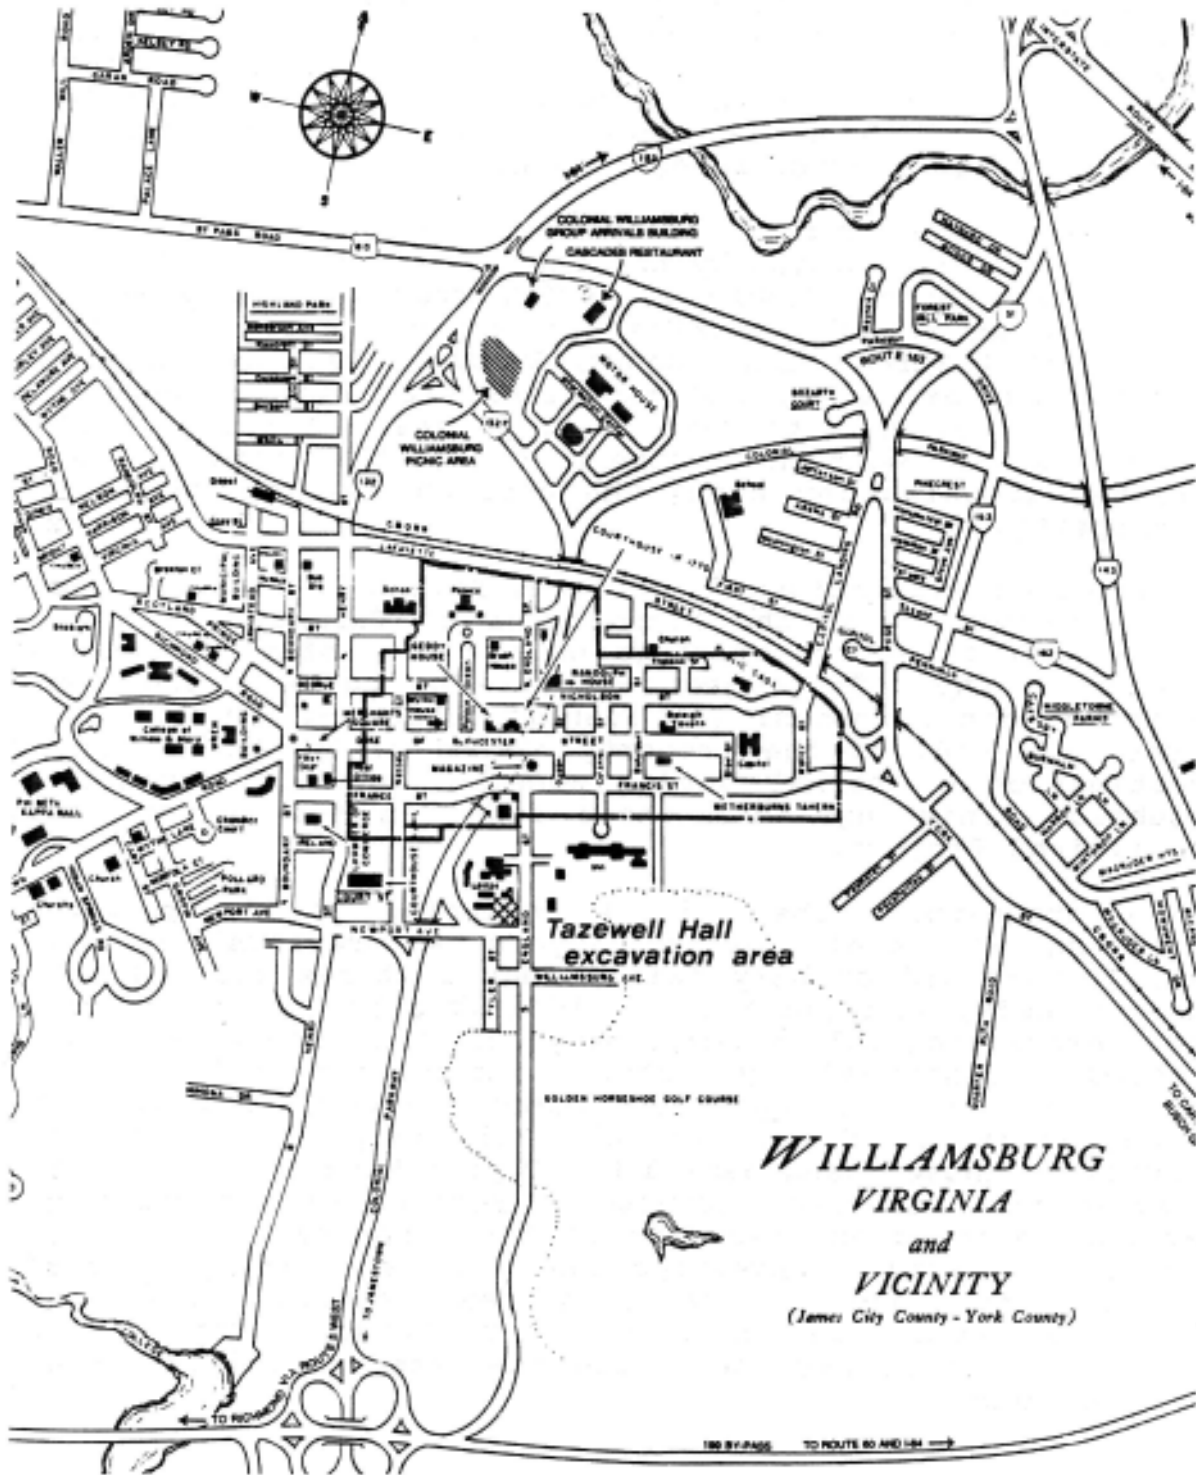
Figure 1. Location of the Tazewell Hall property.

The former Tazewell Hall property lies on the south side of the City of Williamsburg, just outside the Restored Area of Colonial Williamsburg (Figure 1). The part of the property destined to be impacted was bounded by the Williamsburg Lodge on the north and west, South England Street on the east, and Newport Avenue on the south. This area had previously been designated by the Colonial Williamsburg Architecture Department as Block 44, Archaeological Area B (Knight 1948).

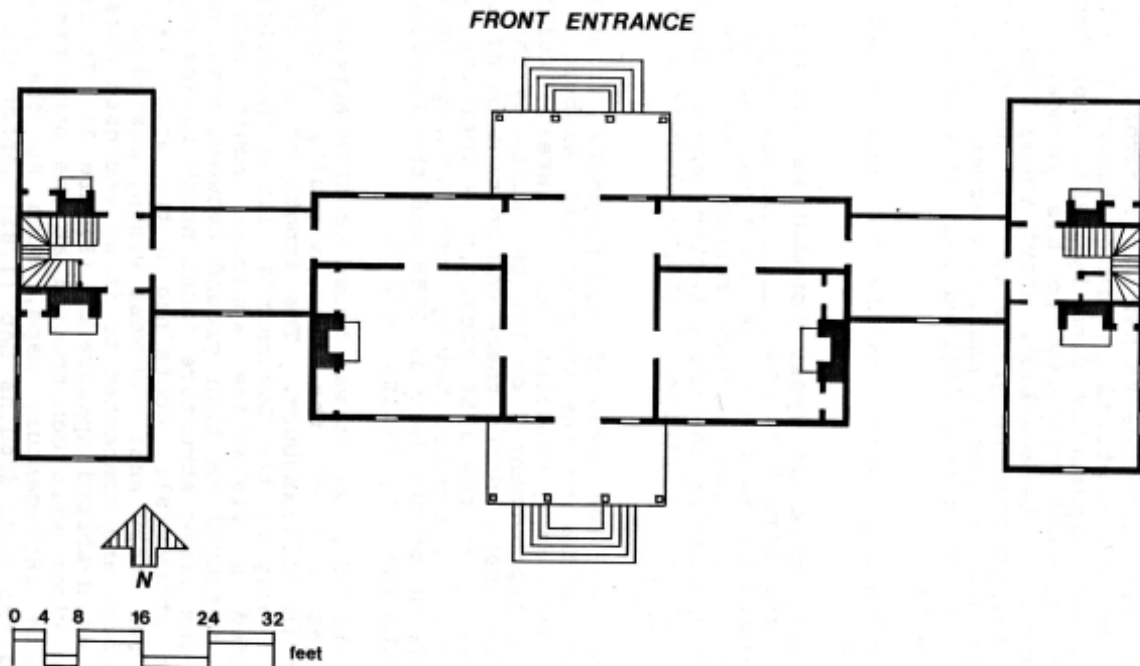
Figure 3. Plan of the 18th-century Tazewell Hall. (Taken from S.P. Moorehead, "Tazewell Hall—18th Century Conditions" [Map, CWI Architectural Department, 1949])

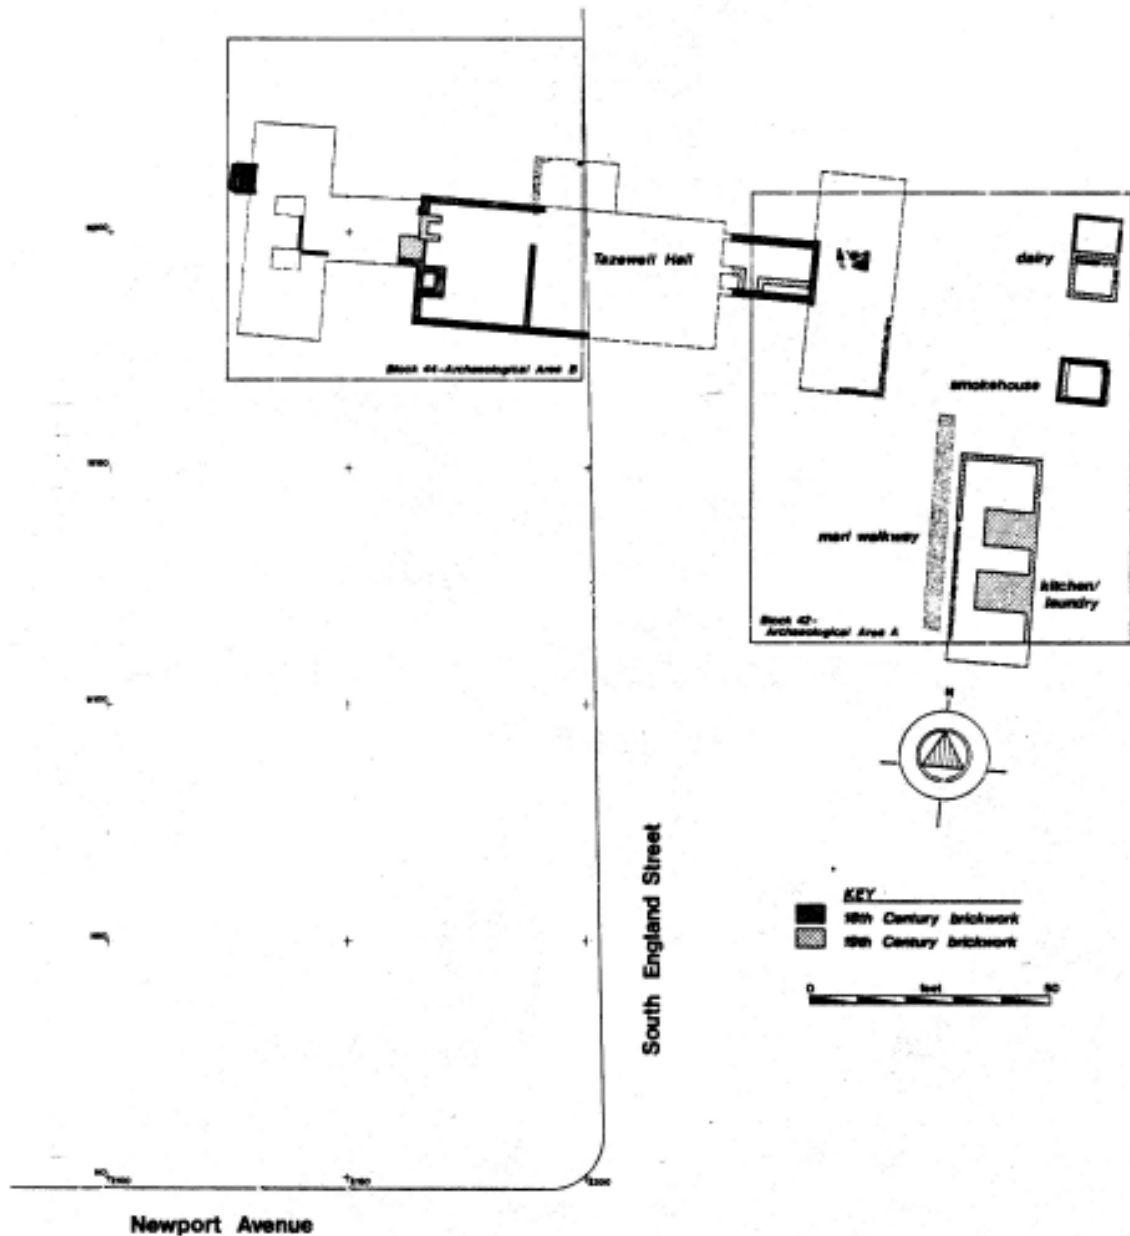
Figure 6. Features uncovered by James Knight, October-November, 1948.

Despite the lack of a written report by Mr. Knight, maps and photographs of the excavation do exist. The map of archaeological features, prepared by Knight, shows four foundations: the colonial house, two dairies, two smokehouses, and a kitchen/laundry (Figure 6).

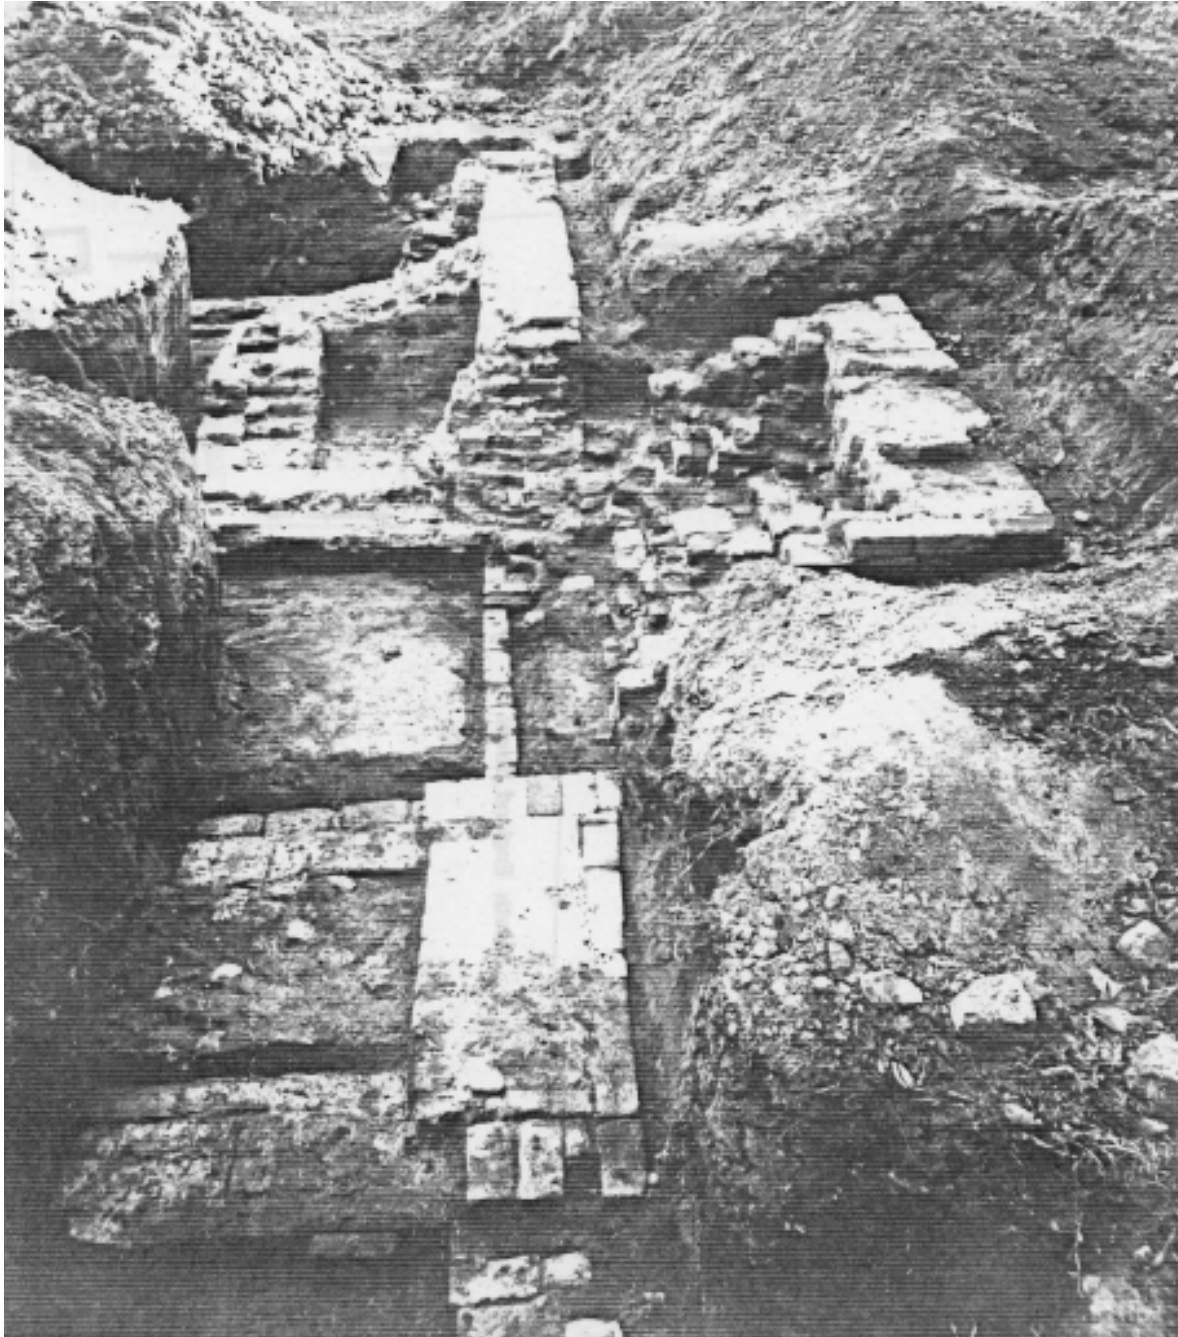
Figure 7. West foundation wall of main house.

The part of the main house found in Area 44-B was about 35' E/W and 27' N/S, with two interior hearth bases uncovered along the west wall (Figure 7). An interior partition and a 19th-century bulkhead entrance to the main house cellar were also found. The foundation was 12 courses high, 16³/₄" thick, and set in English bond with shell

mortar. Brick size was noted as 8¹/₄" × 4" × 2¹/₄" to 2¹/₂".

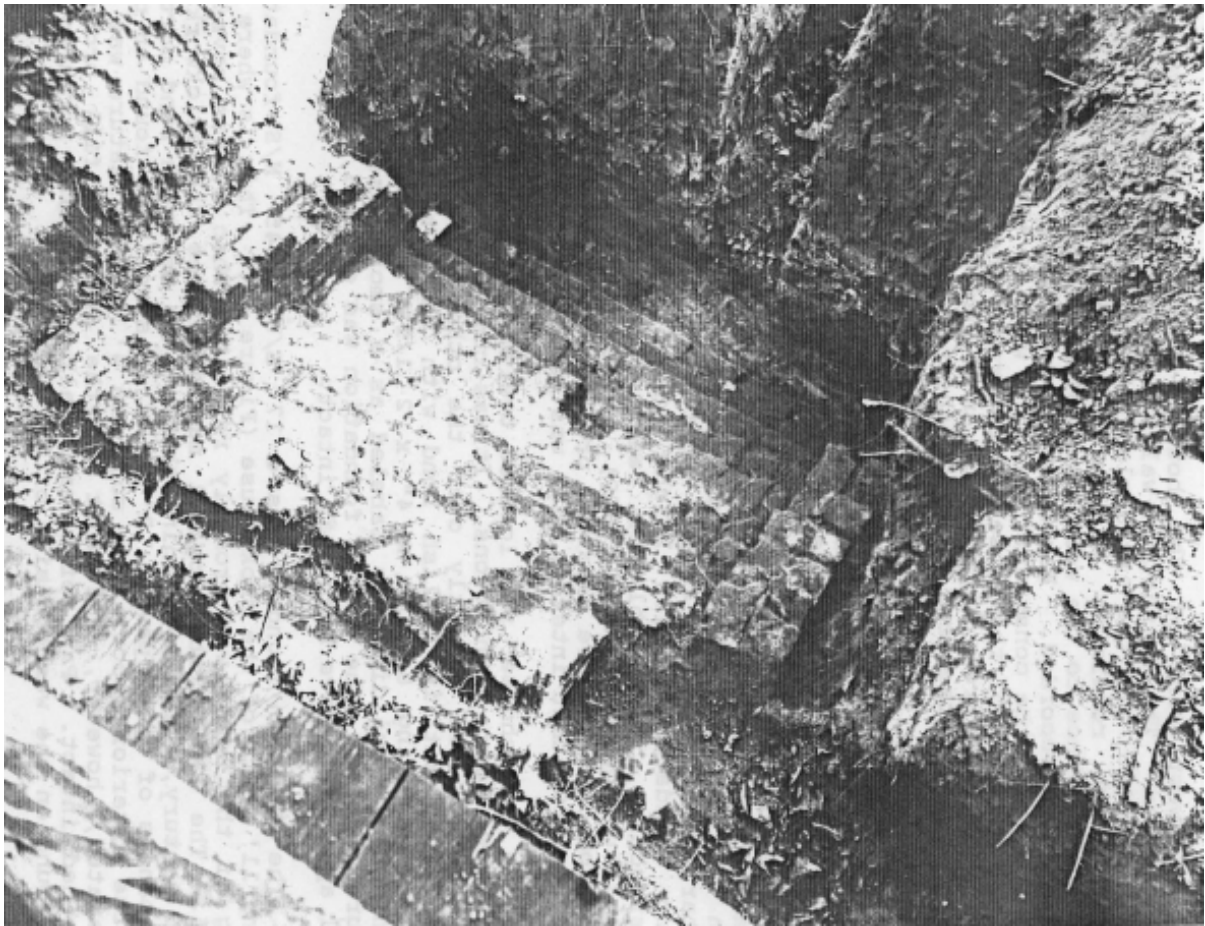
Figure 8. Bulkhead entrance into west wing cellar.

The bulkhead entrance to the west wing cellar, also still intact, was cleared and recorded. Based on a comparison of brick sizes, Knight assigns the construction of the wing to the same period as the main portion of the house. Photographs show fairly extensive digging in this area (Figure 8). An L-shaped interior partition (?) and two hypothesized interior chimney bases were also noted on the map.

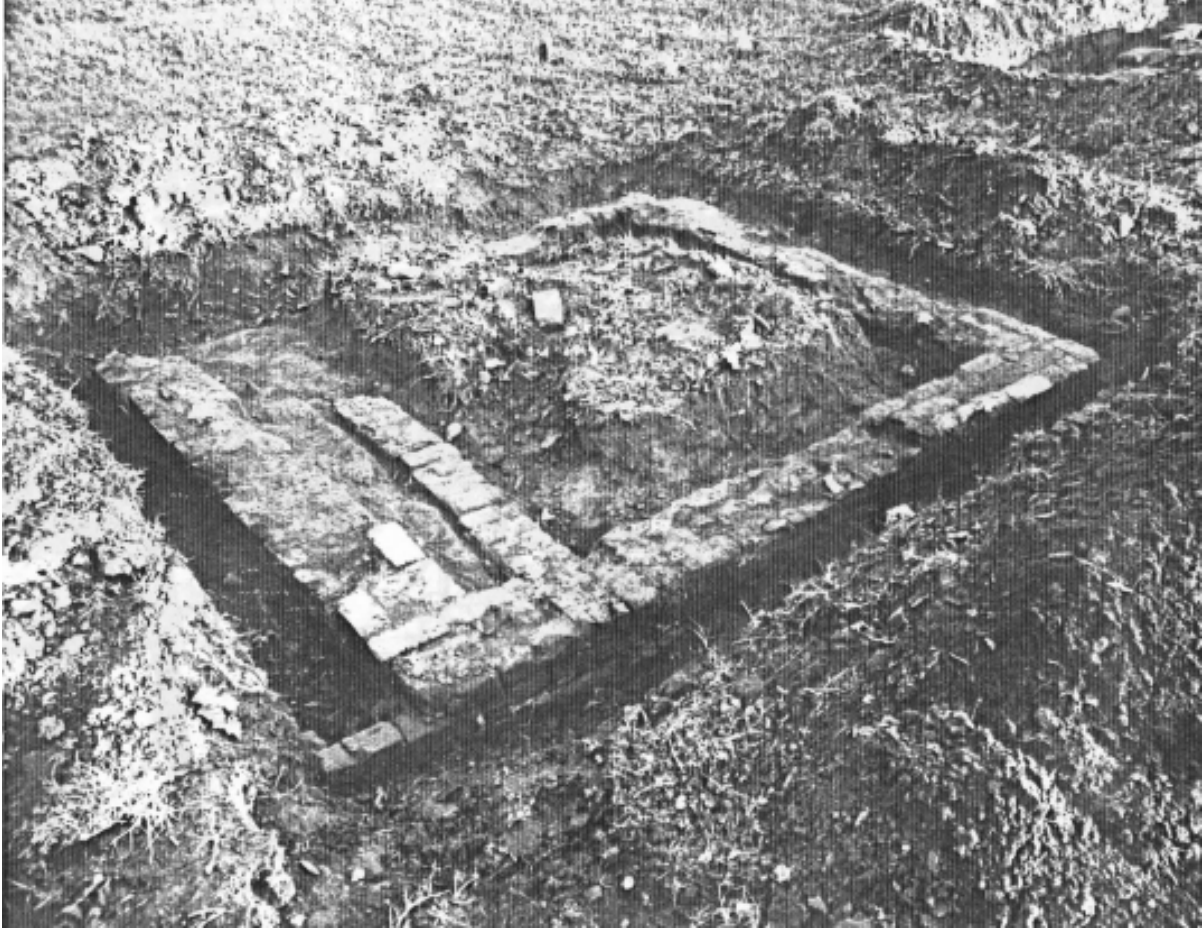
Figure 9. Foundation of dairy.

The “dairy” was composed of two overlapping 10' by 10' brick foundations (Figure 9). The earliest, probably dating to the 18th century, is described as being of English bond with shell

mortar, with $8\frac{1}{4}'' \times 4'' \times 2\frac{1}{2}''$ bricks. Either this or the later foundation, which Knight stated was of 19th century construction, is probably the feature labeled as a dairy on the 1809 insurance map (M.A.S. 1809). Photographs show that both of these foundations were cleared, probably destroying the builder’s trenches, but that interior fill was probably not excavated.

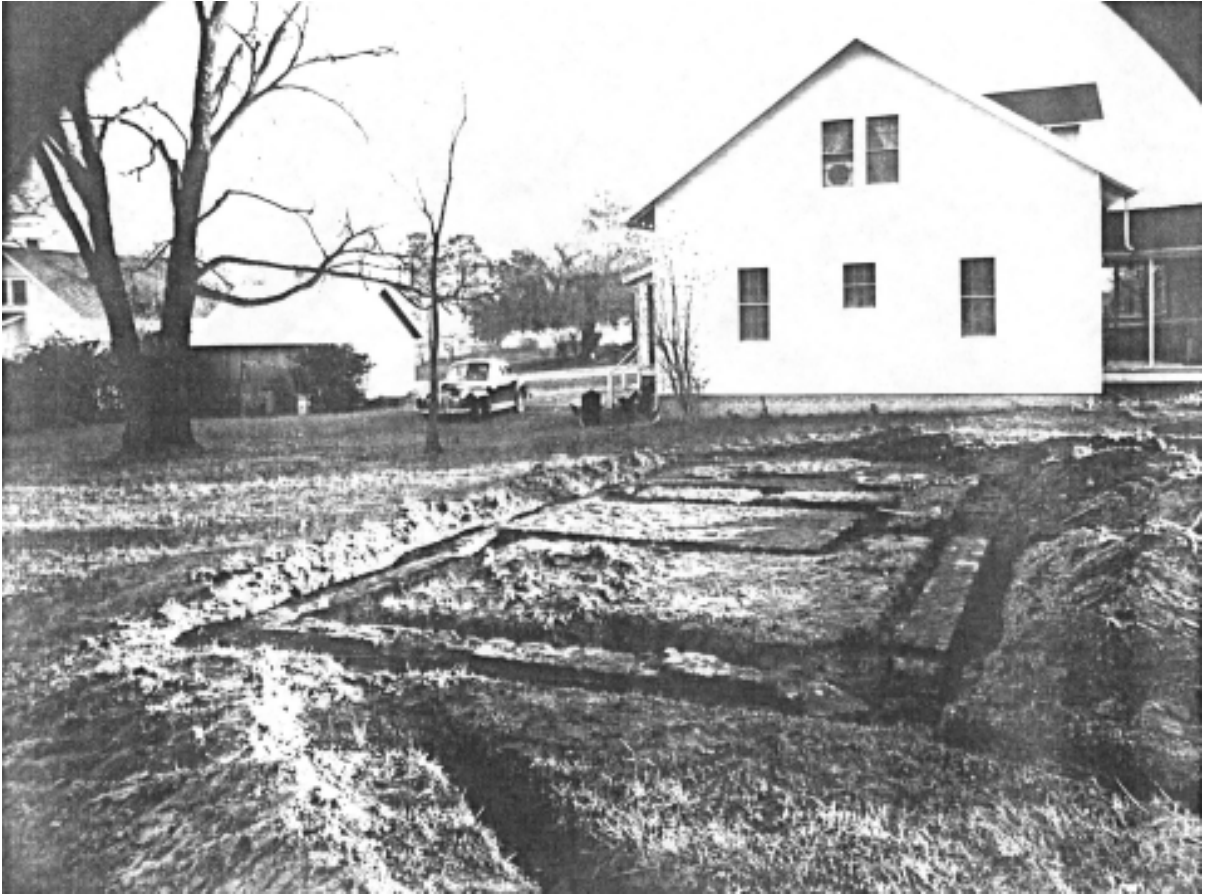
Figure 10. Foundation of laundry/kitchen.

The “kitchen/laundry” was a 17' E/W by 45' N/S foundation lying 11' south of the smokehouse (Figure 10). This is where one wing of the house was probably relocated when it was moved in 1835. The 1948 archaeological map describes the brickwork as 19th century, probably meaning that it was set with sand mortar. Two panels of brick paving, 2' by 6' in size, were found on part of the interior floor. The southern 4' of the feature was not excavated, however, and most of the interior fill probably remained intact. Part of a marl walkway, running north-south, was found on the western side of the foundation.

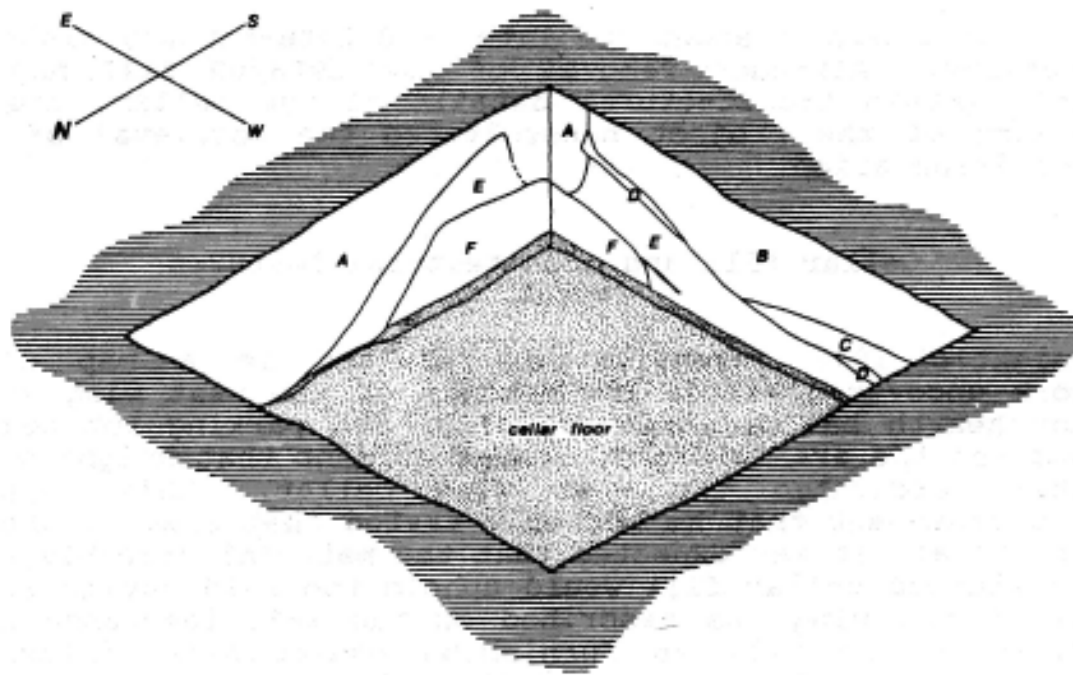
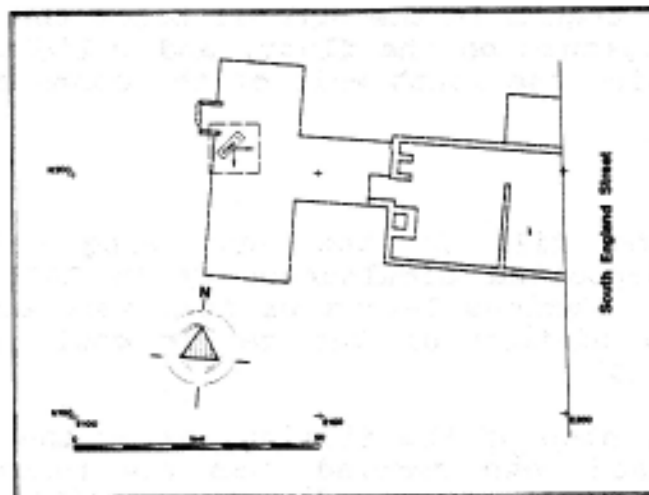
- A disturbed fill from 1948 excavation [44B-292, -293]
- B orange clay II [44B-130, -154]
- C greyish-brown sandy loam [44B-153, -155]
- D brick dust [44B-192]
- E rubble II [44B-159, -544]
- F brown sandy loam [44B-195]
- charcoal
- ▨ cellar floor [44B-192, -207]

Figure 12. Isometric profile of west wing cellar fill.

When most of the foundation had been removed, the filling began. The first layer (44B-153, -155, and -302) comprised of brown sandy loam, was dumped in the west part of the cellar. This fill was fairly clean, but included small amounts of

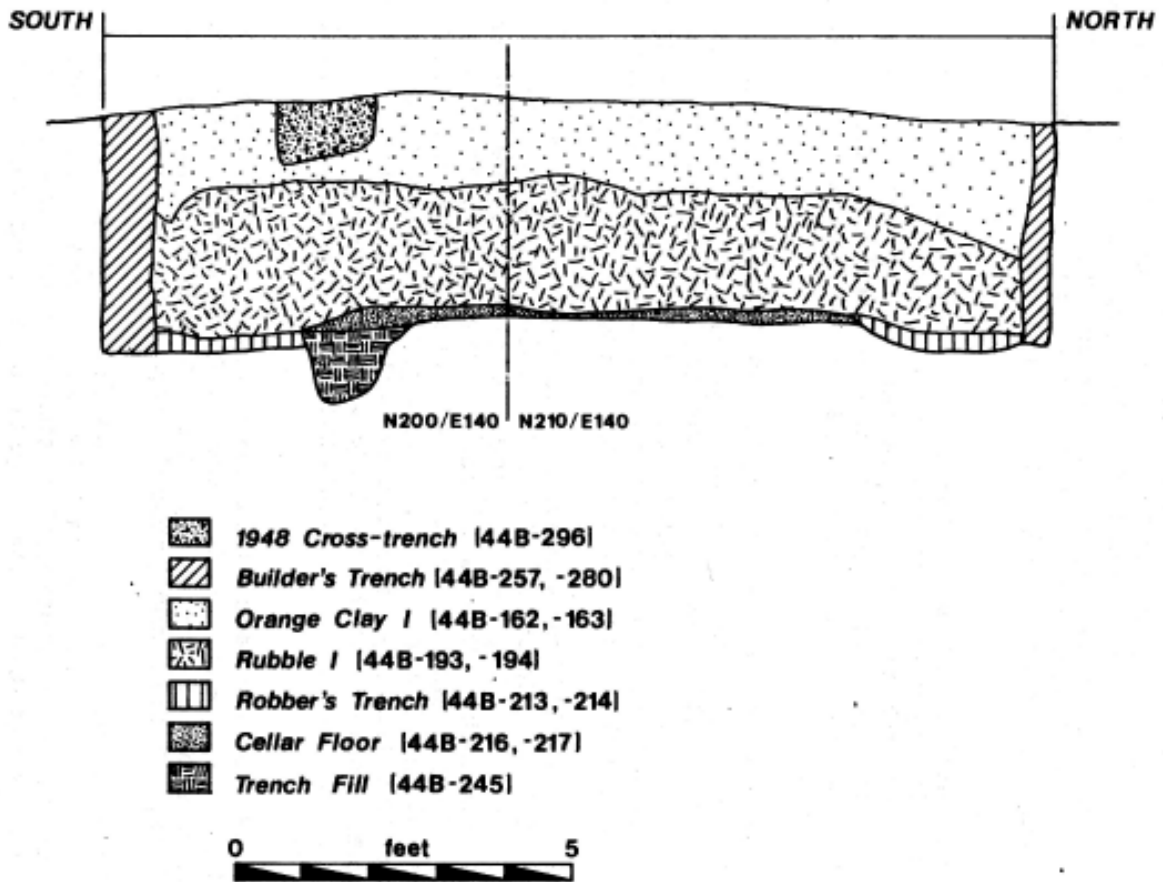
Figure 13. Profile of west passageway.

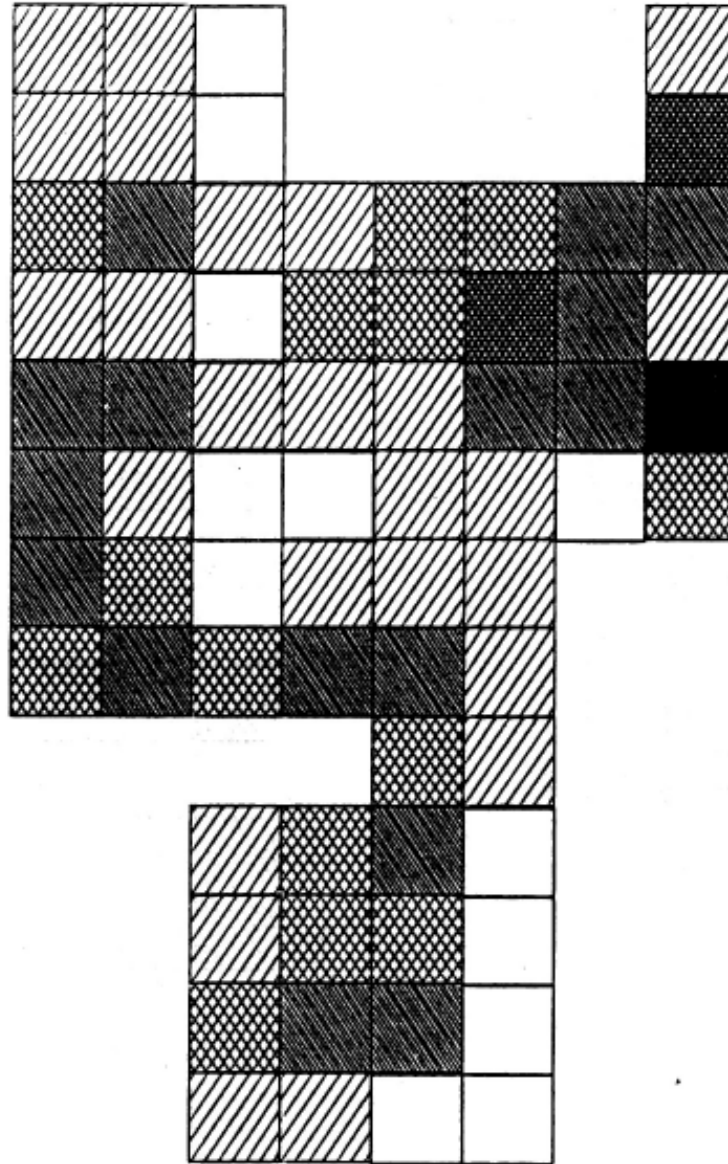
Figure 15. Total artifact distribution of cellar floor.

Although nails and window glass were found distributed over the entire surface of the floor, they also showed distinct clusters in the wing passageway. The distributions of glass likely reflect windows broken during the removal of the wing and pressed into the floor surface during salvaging of the foundation walls. The nails found most likely also reflect activities associated with the wing removal. Of the 132 identifiable nails from the floor surface, 59.9% were of the hand-wrought vari-

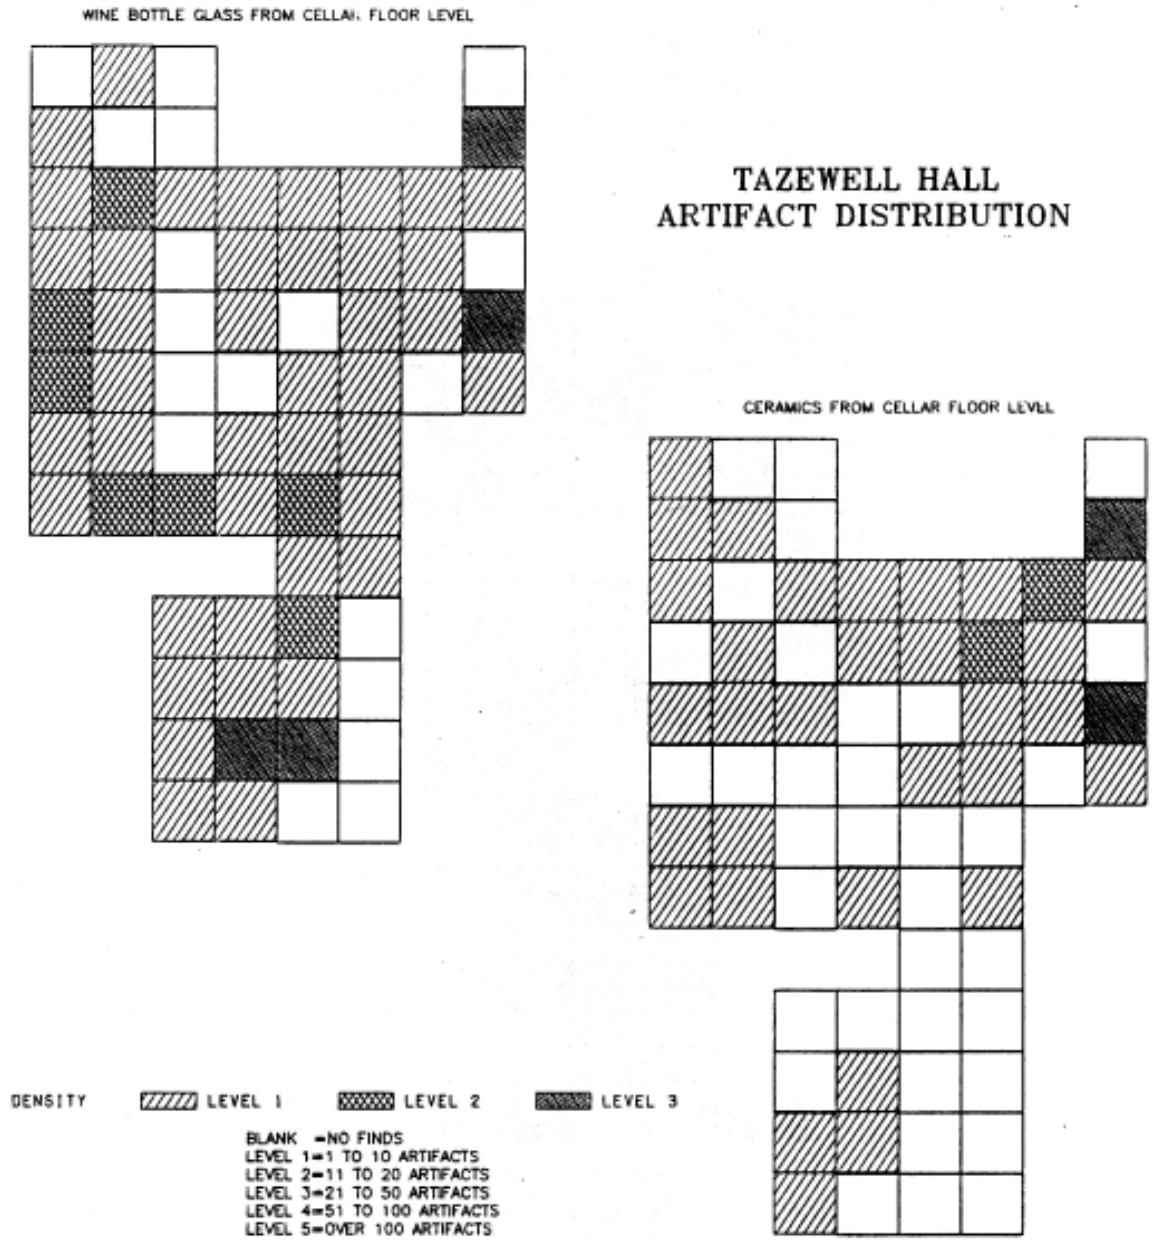
Figure 16. Wine bottle glass and ceramic distributions from cellar floor.

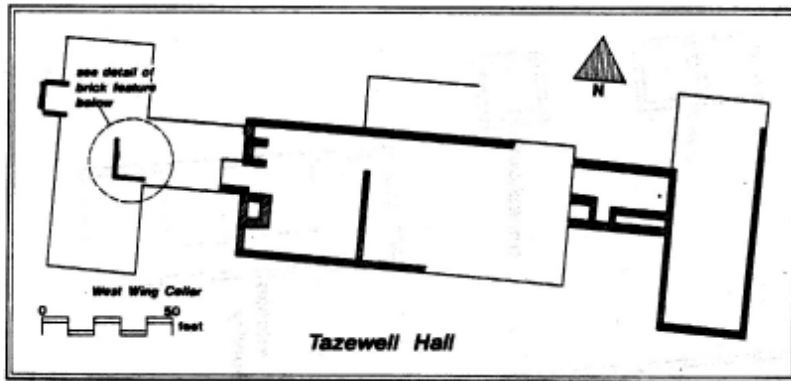
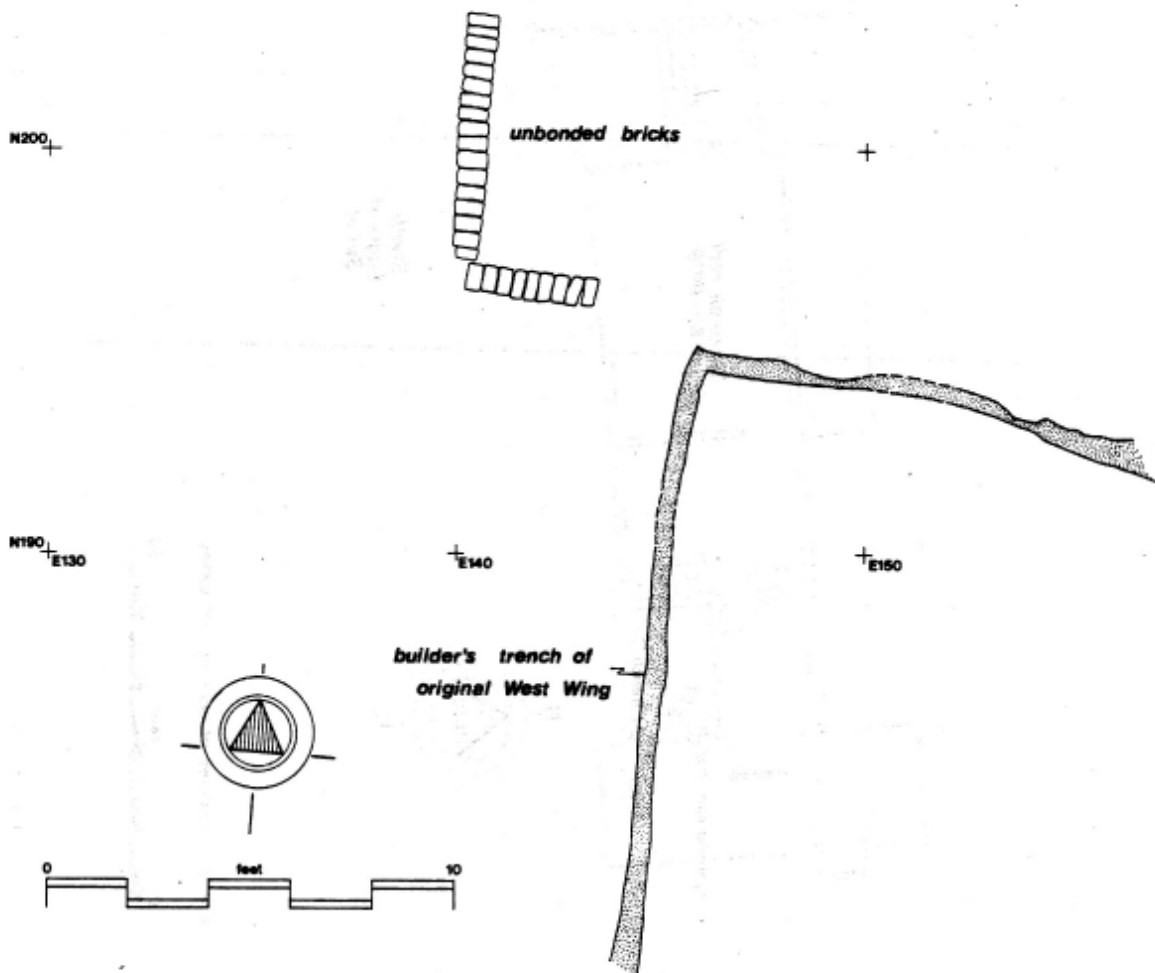
Figure 18. L-shaped brick sill.

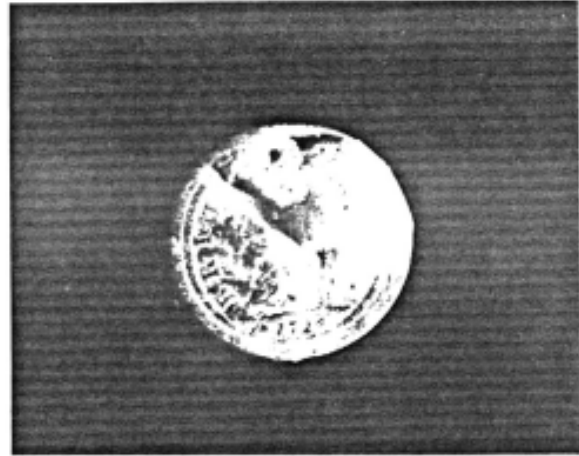
Figure 25. 1724 British halfpenny found in marl walkway.

Pressed into the top of the marl, but possibly deposited with the 1835 destruction layer, was a 1724 British halfpenny covered on both sides with shell mortar (Figure 25). The mortar suggests that the coin was placed within the foundation of the west wing during its construction around 1762,

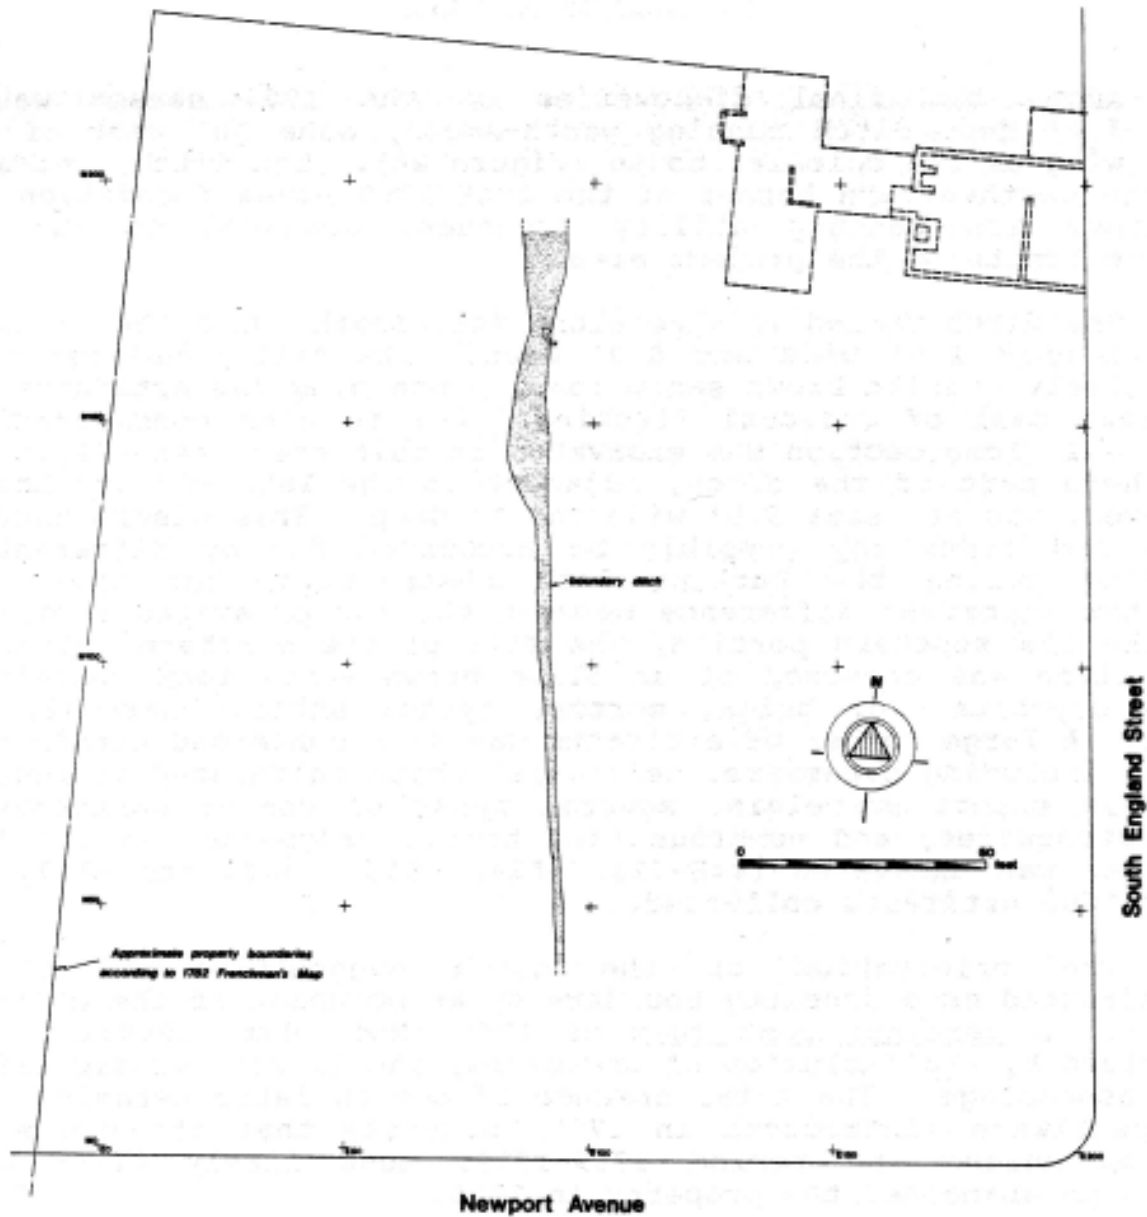
Figure 26. Boundary ditch.

This feature can be evaluated in terms of the changing landscape needs of the property through time and across ownership. The boundary ditch was constructed on the property sometime during the Randolph period and perhaps served to separate the formal back yard from a more utilitarian portion of the property. This separation of the two portions of the property continued into the 19th century. The western side of the Tazewell Hall property can be seen on a pre-Civil War watercolor (Figure 27) as a cleared area, separated from the immediate back yard by a fence. Abutting the fence is a large wooden outbuilding, appearing to be a stable or barn. This may be the same structure as that depicted to the west of the house on the Frenchman’s and the Desandrouins Maps. More of what appear to be farm-related outbuildings appear to the north in the watercolor. It is evident that the western portion of the property, throughout its history, served utilitarian functions, perhaps as fields for grazing livestock or as agricultural lands. By the mid-19th century, this portion of the property was separated from the

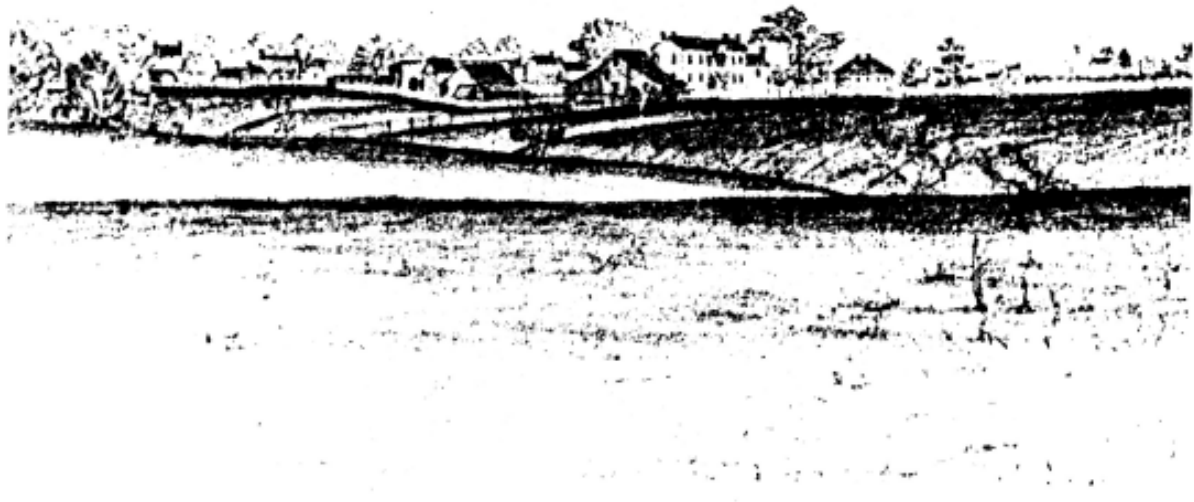
Figure 27. Williamsburg VA: South View showing Tazewell Hall.

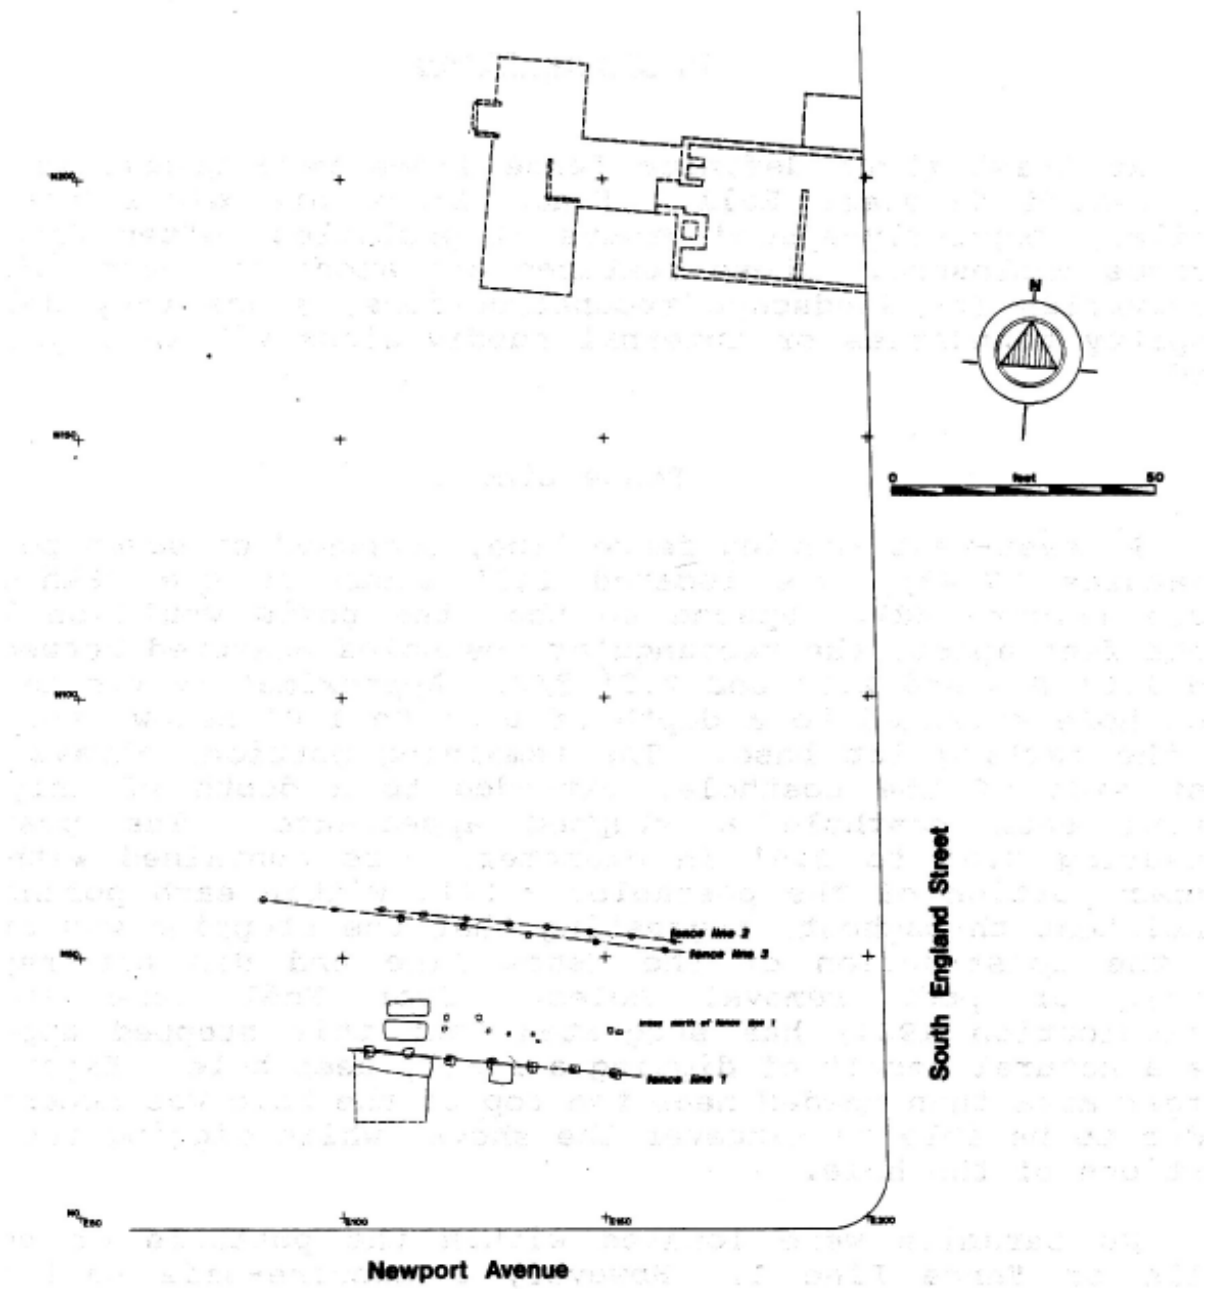
Figure 28. Fence Lines.

A second fence line, lying 120' south of the colonial house, was located 25' north of Fence Line 1 (see Figure 28). The eight ovate to round postholes (Features 45-52) were smaller, ranging from 1.0' to 1.5' in diameter and 0.65'-1.0' deep. They were spaced fairly regularly, 6-7' apart, and contained 0.5'-0.65' diameter postmolds. The smaller size of the postholes and postmolds suggests that a less substantial fence was erected here than along Fence Line 1. A *terminus post quem* of 1805 for the posthole fill

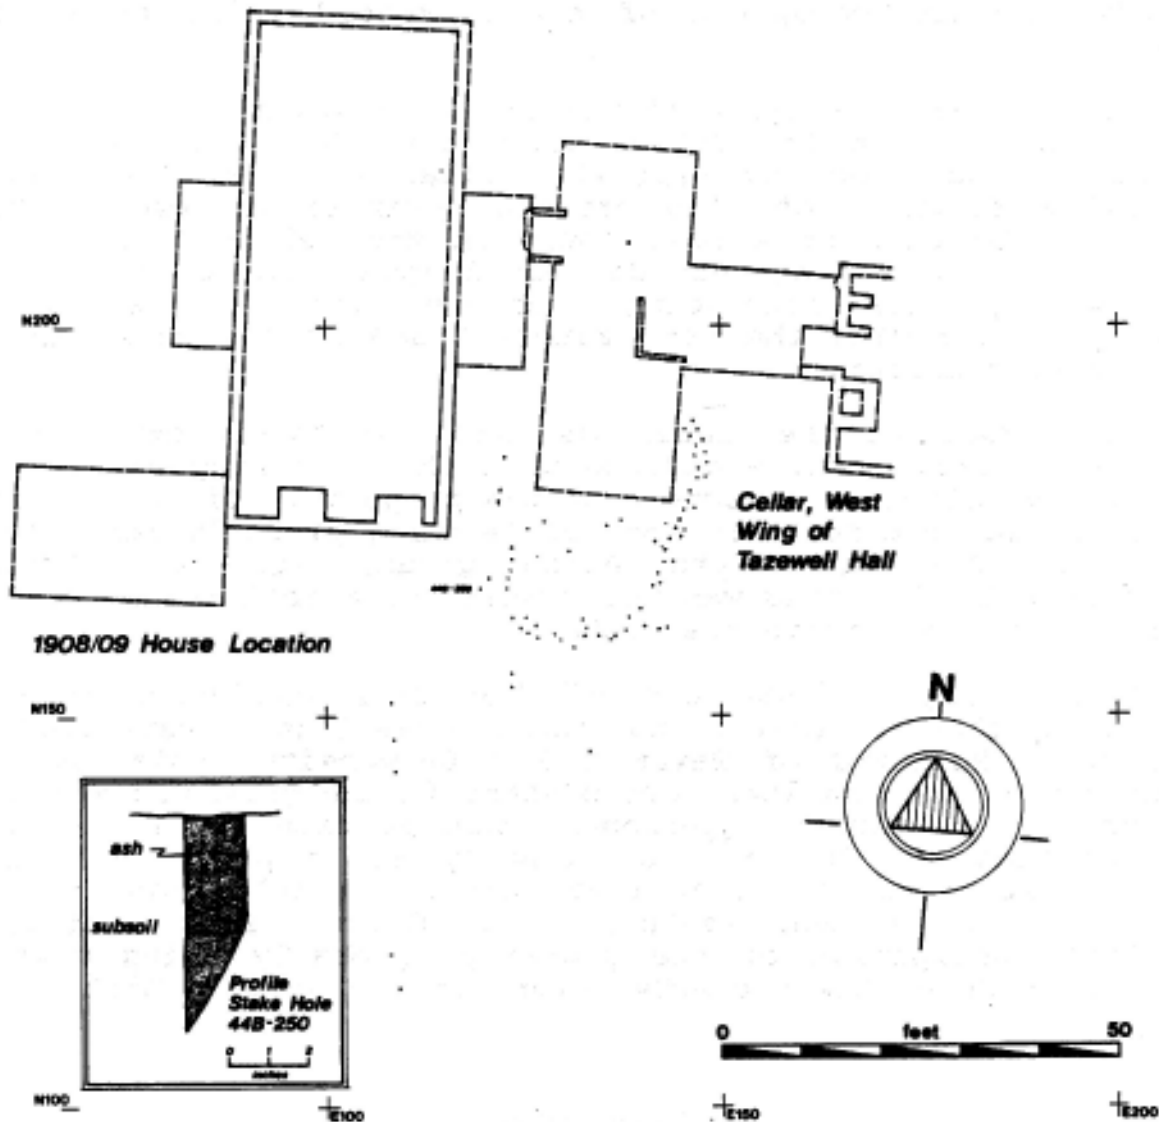
Figure 32. Plan and profile of stake holes at Tazewell Hall.

Although the stake features clustered in a semicircular pattern around the end of the west wing, several holes were located outside this area, perhaps suggesting that they did not all date to the same period. Dating of these features, as with others on the site, proved to be difficult, since all overlying stratigraphic layers had been stripped when the parking lot was constructed. Therefore, these features could date any time from the 18th to the 20th century. They were located in what would have been the front yard of the 1908/1909 house, and it is likely that they were associated with the Susannah Garrett/Peyton Randolph
